Accessibility
Self Evaluation and Transition Plan
Apostle Islands National Lakeshore

Apostle Islands National Lakeshore (APIS) has prepared this Self Evaluation and Transition Plan to ensure we are providing comparable opportunities to experience the park to all visitors, regardless of their abilities. As a public entity, APIS is obligated to ensure that our programs, services and facilities are accessible to all visitors based on *Section 504 of the Rehabilitation Act of 1973* which prohibits discrimination against individuals based on disability.

This report was created after conducting site visits to sites and islands within the park and a review of the programs and interpretive media available to park visitors in the summer of 2011. The following documents were used as the basis for recommendations, some of which are specific to the National Park Service:

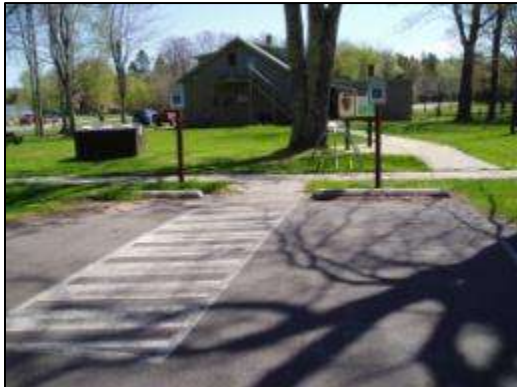
1. APIS Little Sand Bay – Visitor Contact Station. View of accessible parking and route to visitor contact station.

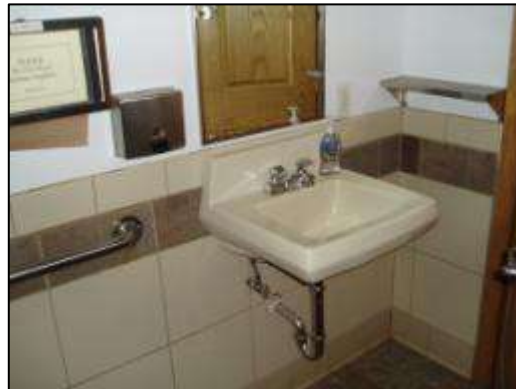
10. APIS Little Sand Bay – Visitor Contact Station. The waste pipes at the sink are not currently wrapped or protected to prevent cuts and/or burns.

Toilet Room (front)	The waste pipes on the lavatory are not currently insulated. ABA 606.5	<ul style="list-style-type: none"> ➤ Insulate the pipes at the lavatory. 	3	Short term
Toilet Room (front)	The locking mechanism for the door currently requires tight grasping and twisting of the wrist to operate. ABA 309.4	<ul style="list-style-type: none"> <input type="checkbox"/> Replace the door lock (integrated into the door lever). ➤ Add an additional lock. 	2	Long term
Toilet Room (back)	The toilet is currently centered 19" from the side wall (instead of 16"-18"). A total of 58" clearance is provided. ABA 604.2	<ul style="list-style-type: none"> <input type="checkbox"/> Relocate the toilet so it is centered 16"-18" from the side wall. ➤ No action, the front toilet room can be made fully accessible. 	3	Long term
Toilet Room (back)	A clearance at the toilet of 58" is currently provided perpendicular from the side wall (60" minimum required). ABA 604.3	<ul style="list-style-type: none"> <input type="checkbox"/> Relocate the lavatory to provide 60" minimum clearance. <input type="checkbox"/> Enlarge the room to provide 60" minimum clearance. ➤ No action, the front toilet room can be made fully accessible. 	3	Long term

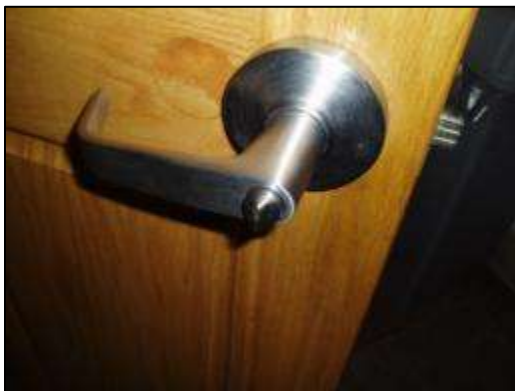
11. APIS Little Sand Bay – Visitor Contact Station. The locking mechanism at the toilet rooms requires tight pinching and twisting of the wrist.

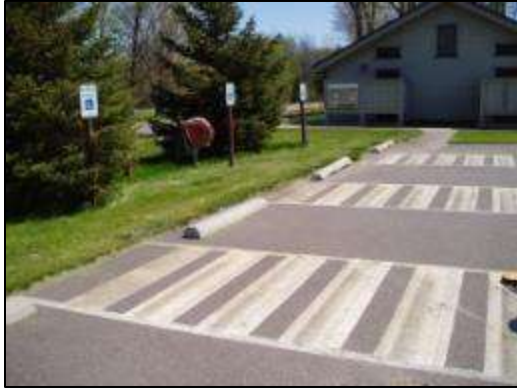
1. APIS Little Sand Bay Restrooms. Accessible parking.

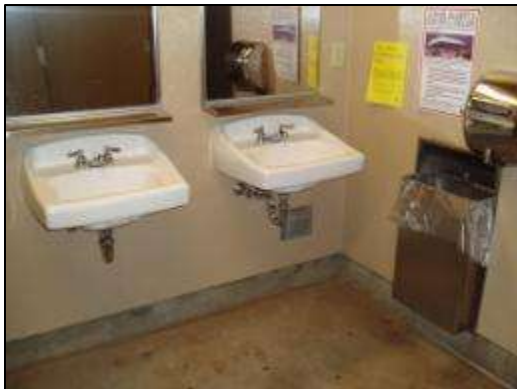
5. APIS Little Sand Bay Restrooms. The waste pipes at the sink are not currently wrapped or protected to prevent cuts and/or burns.

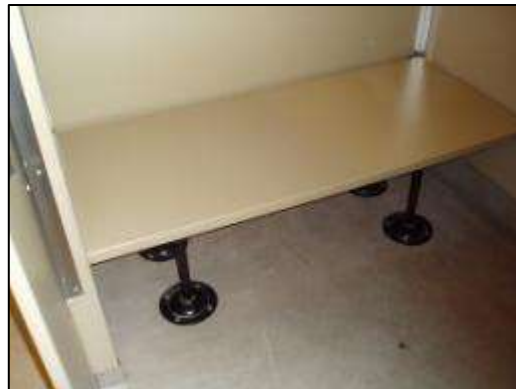
6. APIS Little Sand Bay Restrooms. Bench in changing room. The changing room does not currently provide clear floor space adjacent to the short edge of the bench.

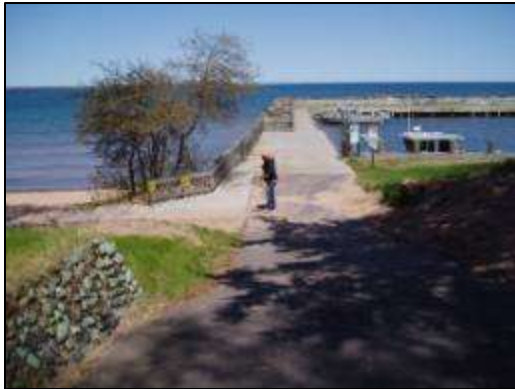
1. APIS Little Sand Bay. Route to dock and beach.

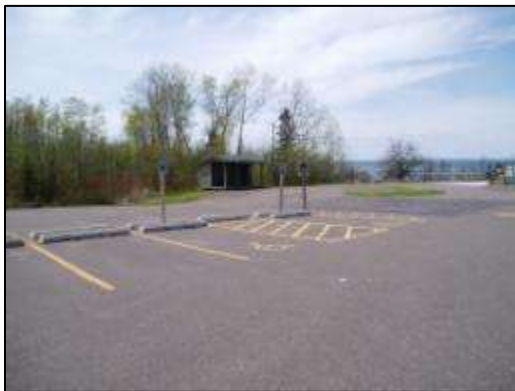
1. APIS Meyers Beach. View of parking lot.

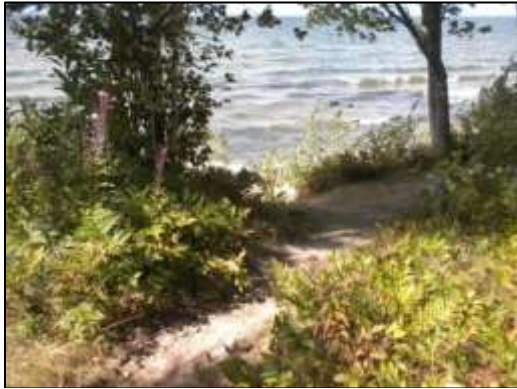
1. APIS Meyers Beach Mainland Campsite. View of route from campsite to beach.

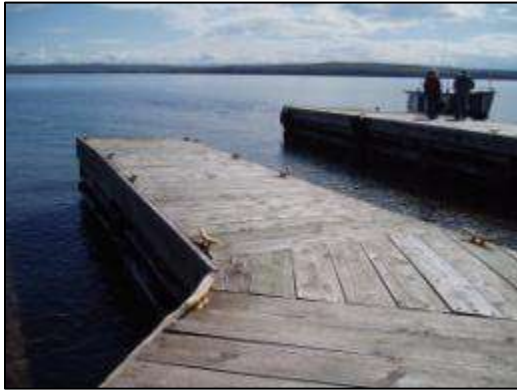
1. APIS Raspberry Island. View of 2nd dock. The 2nd dock has cross slope exceeding 2%. The main dock, used by the concession cruise ship, is level.

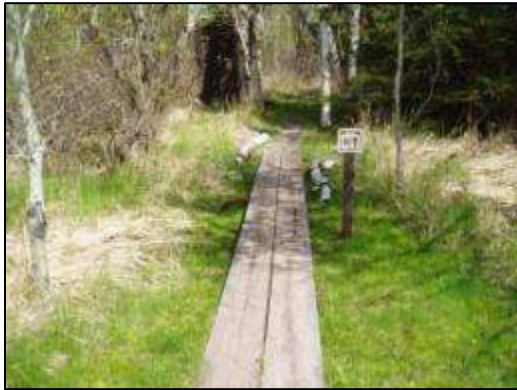
15. APIS Raspberry Island. View of route to vault toilets.
(Vault toilets being replaced Summer 2011, after site visit.)

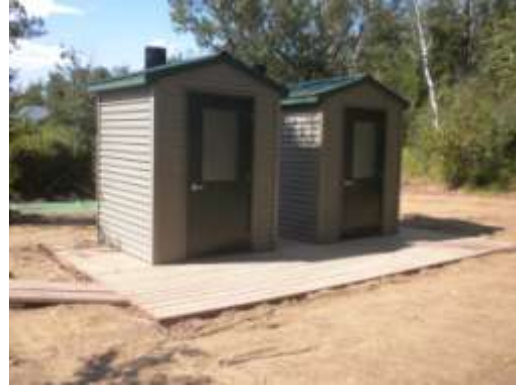
16. APIS Raspberry Island. View of new vault toilets. (The vault toilets were replaced after site visit.)

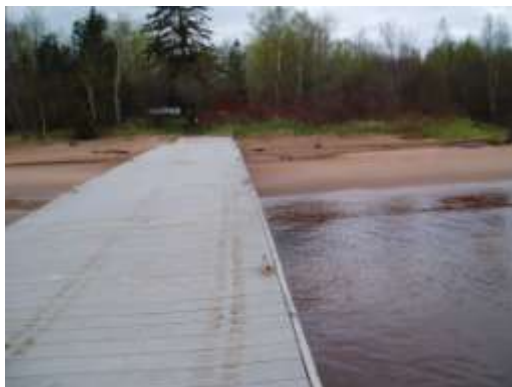
1. APIS Sand Island. Dock.

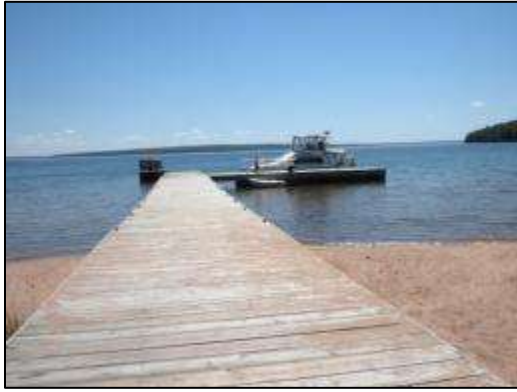
1. APIS Stockton Island Quarry Bay. View of dock.

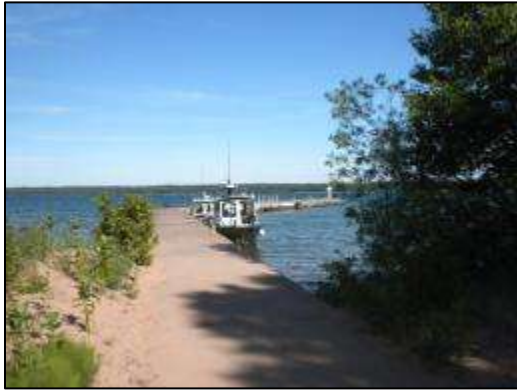
1. APIS Stockton Island Presque Isle. View of dock 1. This dock is used by the concession cruise.

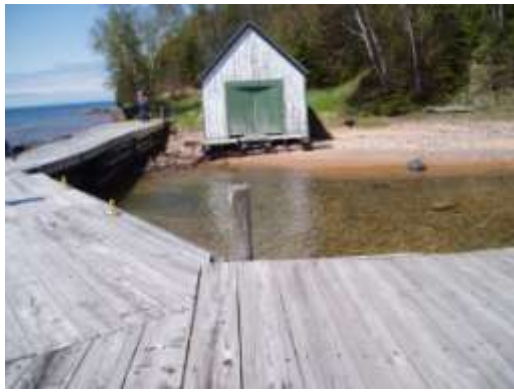
1. APIS Devils Island. Dock and Boathouse.

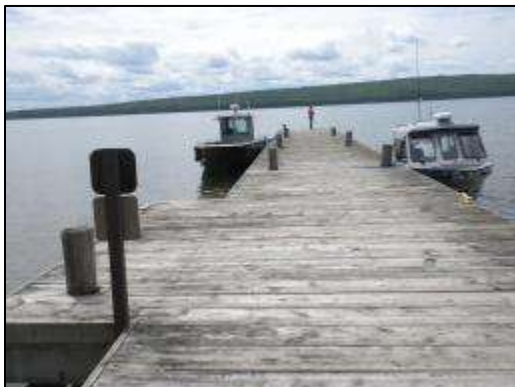
1. APIS Manitou Island. View of dock.

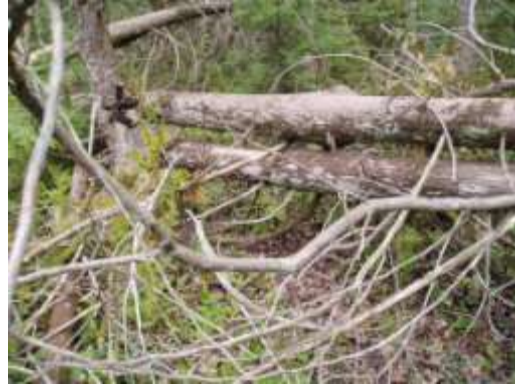
14. APIS Michigan Island. Trail conditions at time of site visit.

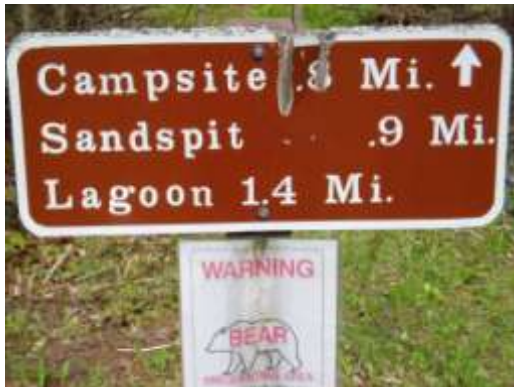
15. APIS Michigan Island. Existing trailhead sign.

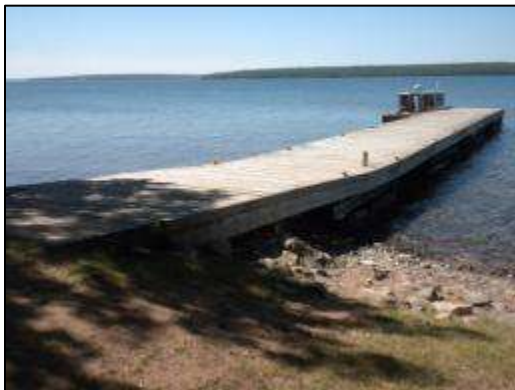
1. APIS Oak Island. Dock.

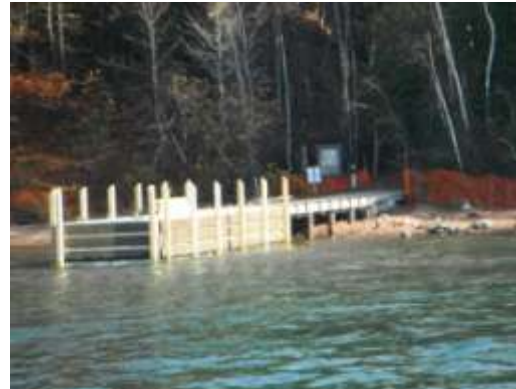
10. APIS Basswood Island. View of new dock. (The dock was replaced after site visit.)

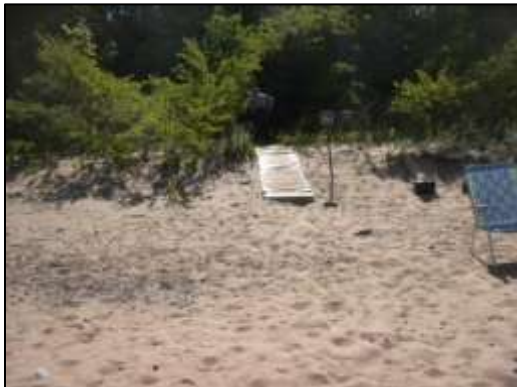
1. APIS Cat Island. The route from the beach to the campsite and moldering privy is sand and a wood boardwalk.

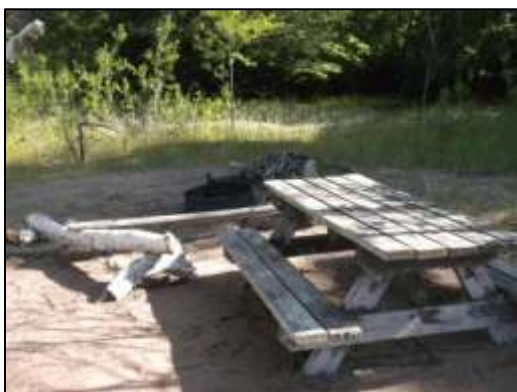
1. APIS Ironwood Island. View of campsite, including picnic table and fire ring.

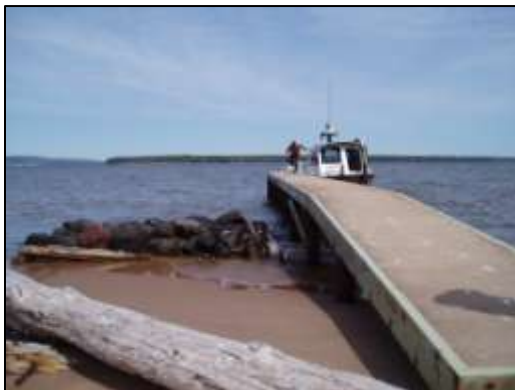
1. APIS Long Island Dock. View of concrete dock.

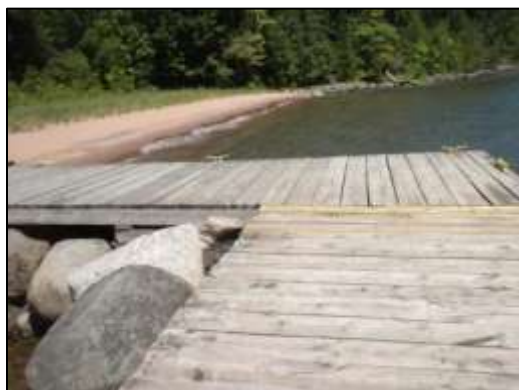
1. APIS Otter Island. View of dock.

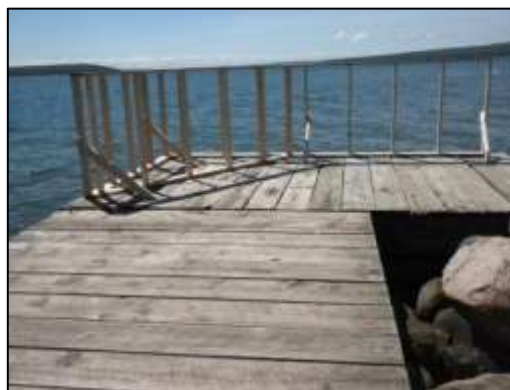
2. APIS Otter Island. View of dock, the corner of the dock was damaged at the time of site visit. A wood structure was constructed to prevent use of that corner of the dock, the structure still provides a clear width for an accessible route.

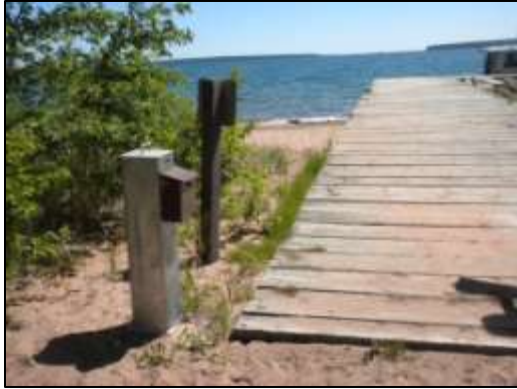
3. APIS Otter Island. The fee station is located near the end of the dock. A clear ground space is not currently provided.

Item	Deficiency	□ Possible Solutions (recommended action indicated by: ►)	Barrier Level	Timeframe
Fee Station	The fee station is positioned near the end of the dock. A clear ground space is not currently provided to approach the fee station. <i>ABA 304.2</i>	<input type="checkbox"/> Relocate the fee station so it is positioned on an accessible route. ► Add to the dock so the fee station is located on an accessible route.	3	Long term
Picnic Area	A picnic area with a picnic table and a fire ring is located in sand near the end of the dock. The picnic table does not currently provide knee and toe clearance. <i>Draft Accessibility Guidelines for Outdoor Developed Areas 1011.4</i>	<input type="checkbox"/> Add an accessible picnic table at an accessible location. ► Replace the existing picnic table with a style that provides knee and toe clearance.	2	Short term
Campsite route	The route from the dock to the campsite is mostly flat and has a sandy surface. The surface is not currently firm and stable. <i>Draft Accessibility Guidelines for Outdoor Developed Areas F244.5</i>	► Add a boardwalk from the end of the dock to the camp site to create an Outdoor Recreation Access Route (ORAR).	3	Long term

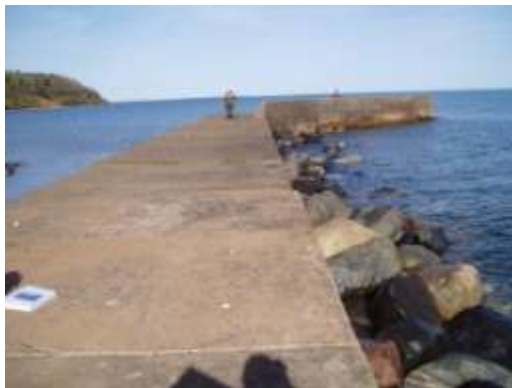
1. APIS Outer Island. Dock.

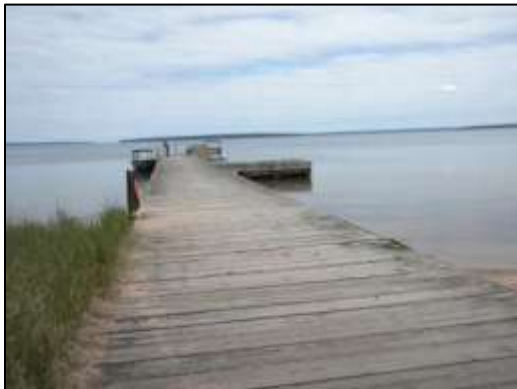
1. APIS Rocky Island. View of dock.

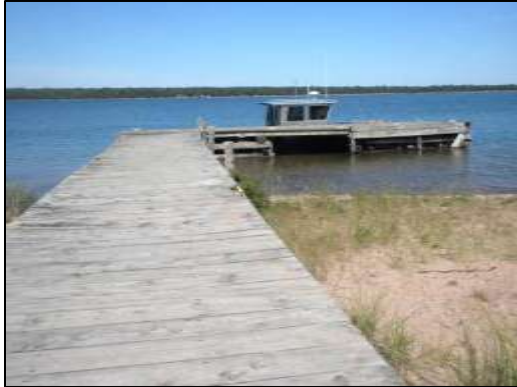
1. APIS South Twin Island. View of dock. The dock was replaced in Summer 2011, after site inspection. (See photos 11 and 12)

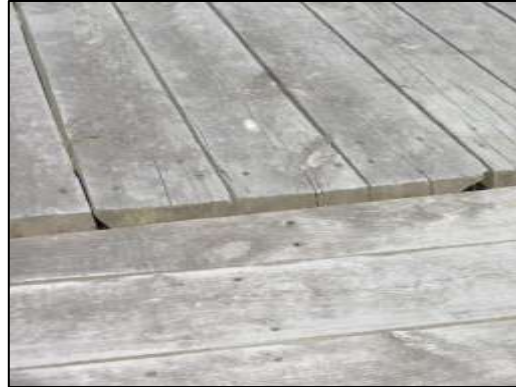
2. APIS South Twin Island. View of vertical change along dock surface. The dock was replaced in Summer 2011, after site inspection. (See photos 11 and 12)

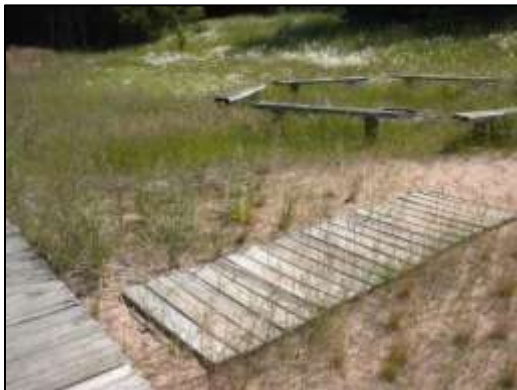
3. APIS South Twin Island. View of the fire ring area. A segment of rolled boardwalk has been provided but does not connect to the main boardwalk.

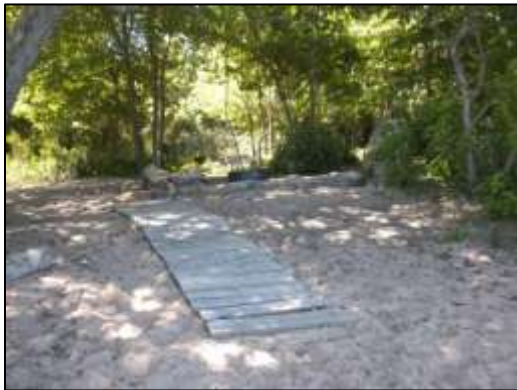
1. APIS York Island. View of route to campsite 2 (routes to sites 1 and 3 are similar).
